2007 SO. CA. FIRES
POOMACHA HARRIS WITCH
BURNED AREA
EMERGENCY
STABLIZATION PLAN

RANCHO BERNARDO CALIFORNIA
NOVEMBER 2007

DOI INTERAGENCY BAER TEAMBURNED AREA EMERGENCY STABILIZATION PLAN

Harris Fire Burned Area Emergency Stabilization Plan

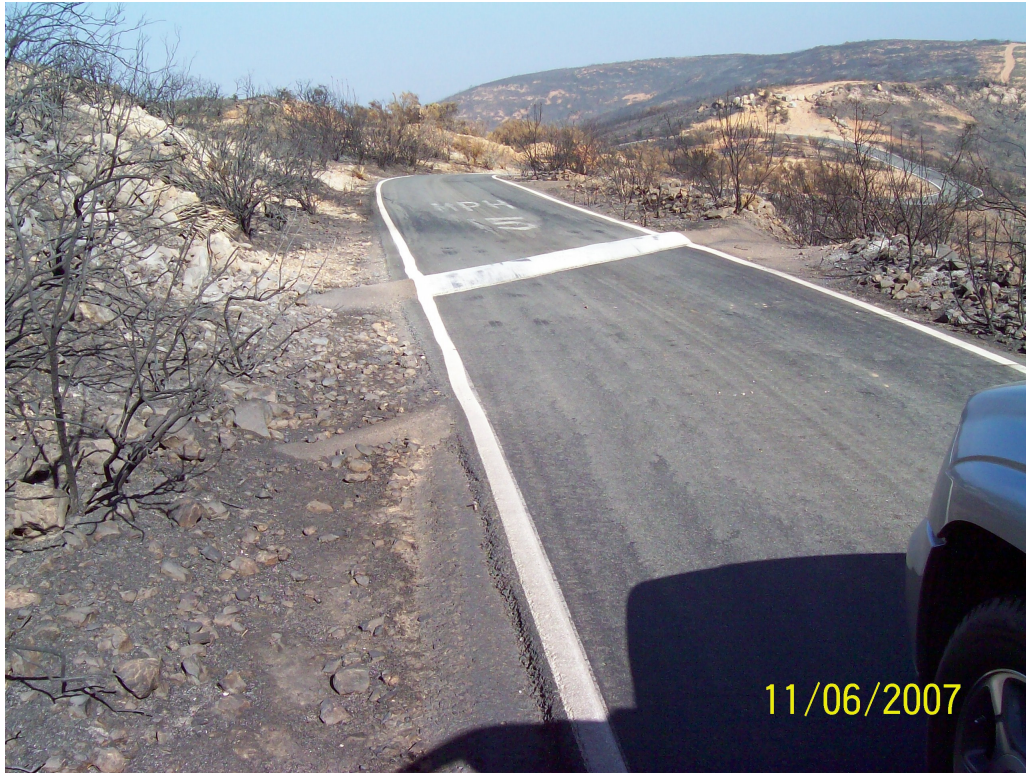
Example of typical asphalt bar, spur and outlet.

- D. Purpose of Treatment Specifications (relate to damage/change caused by fire):** Ash flows and sediment from the fire will create hazardous (slick) road conditions due to the steepness and out sloping of the road. Water bars will stop storm water flows in the road side ditches from accumulating water and depositing debris and ash over large areas of the roadway.

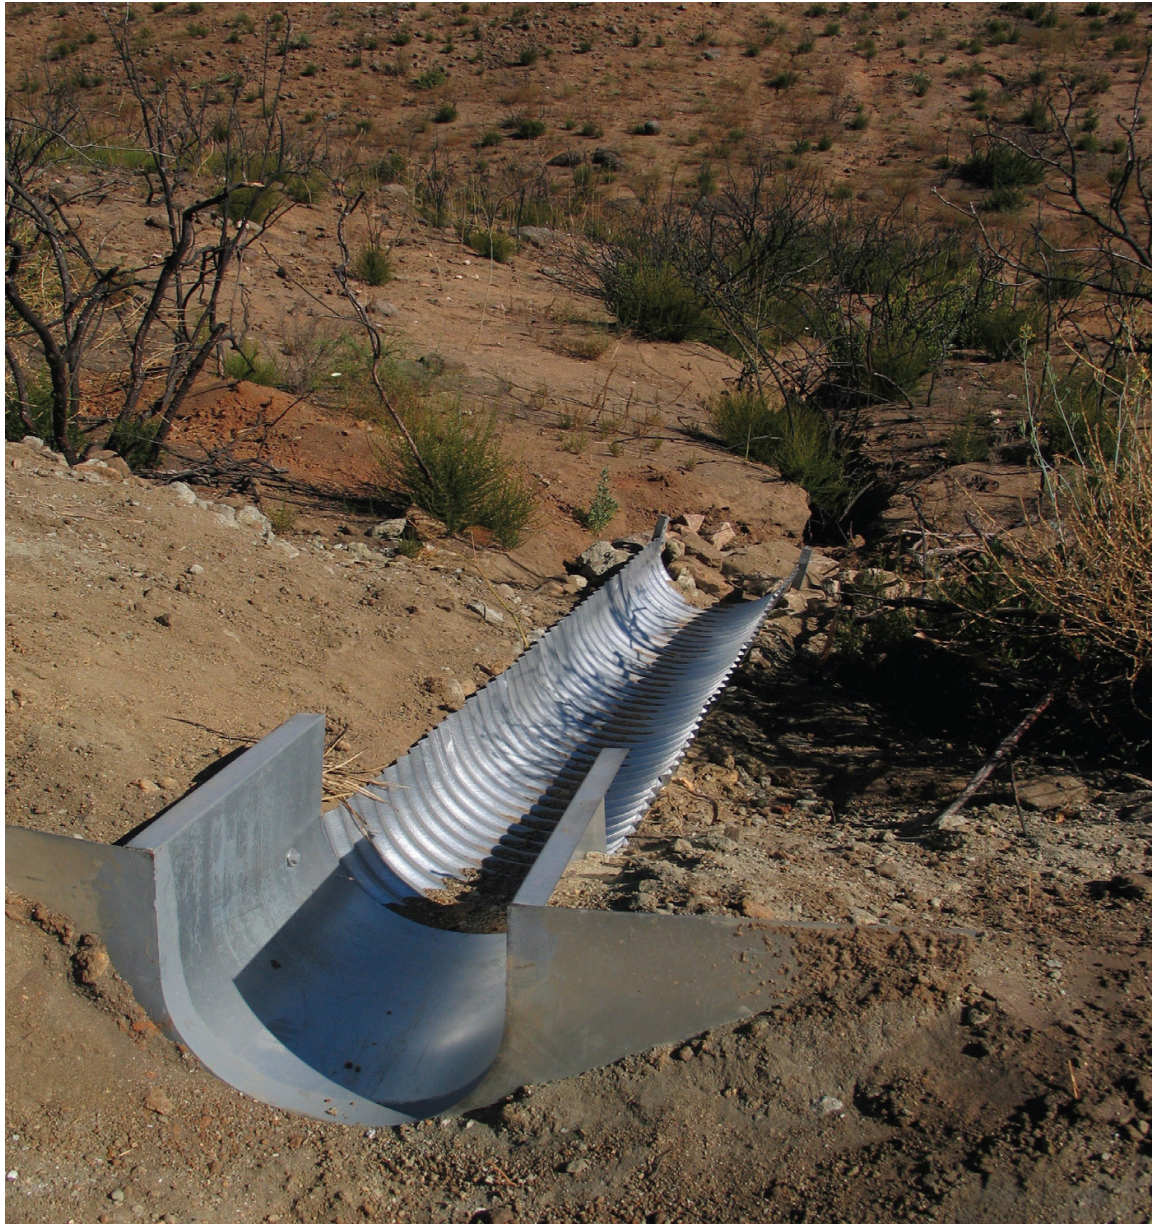
Metal Overside Drain. Page 118, Figure 70 of BAER Treatments Catalog (Dec. 2006)

- D. Purpose of Treatment Specifications (relate to damage/change caused by fire):** The drain outlets will prevent erosion on fill slopes of the road. The burned area will contribute additional water laden with ash and sediment. Water bars concentrate the flow which increases the risk of erosion on the embankment slope.
